RACINE, W. VA.  
NW/4 PEYTONA 15 QUADRANGLE  
N3807.5—W8137.5/7.5

## LANDSLIDES AND RELATED FEATURES

OF THE RACINE, W. VA. QUADRANGLE

OPEN FILE MAP 85-80 (B-3)

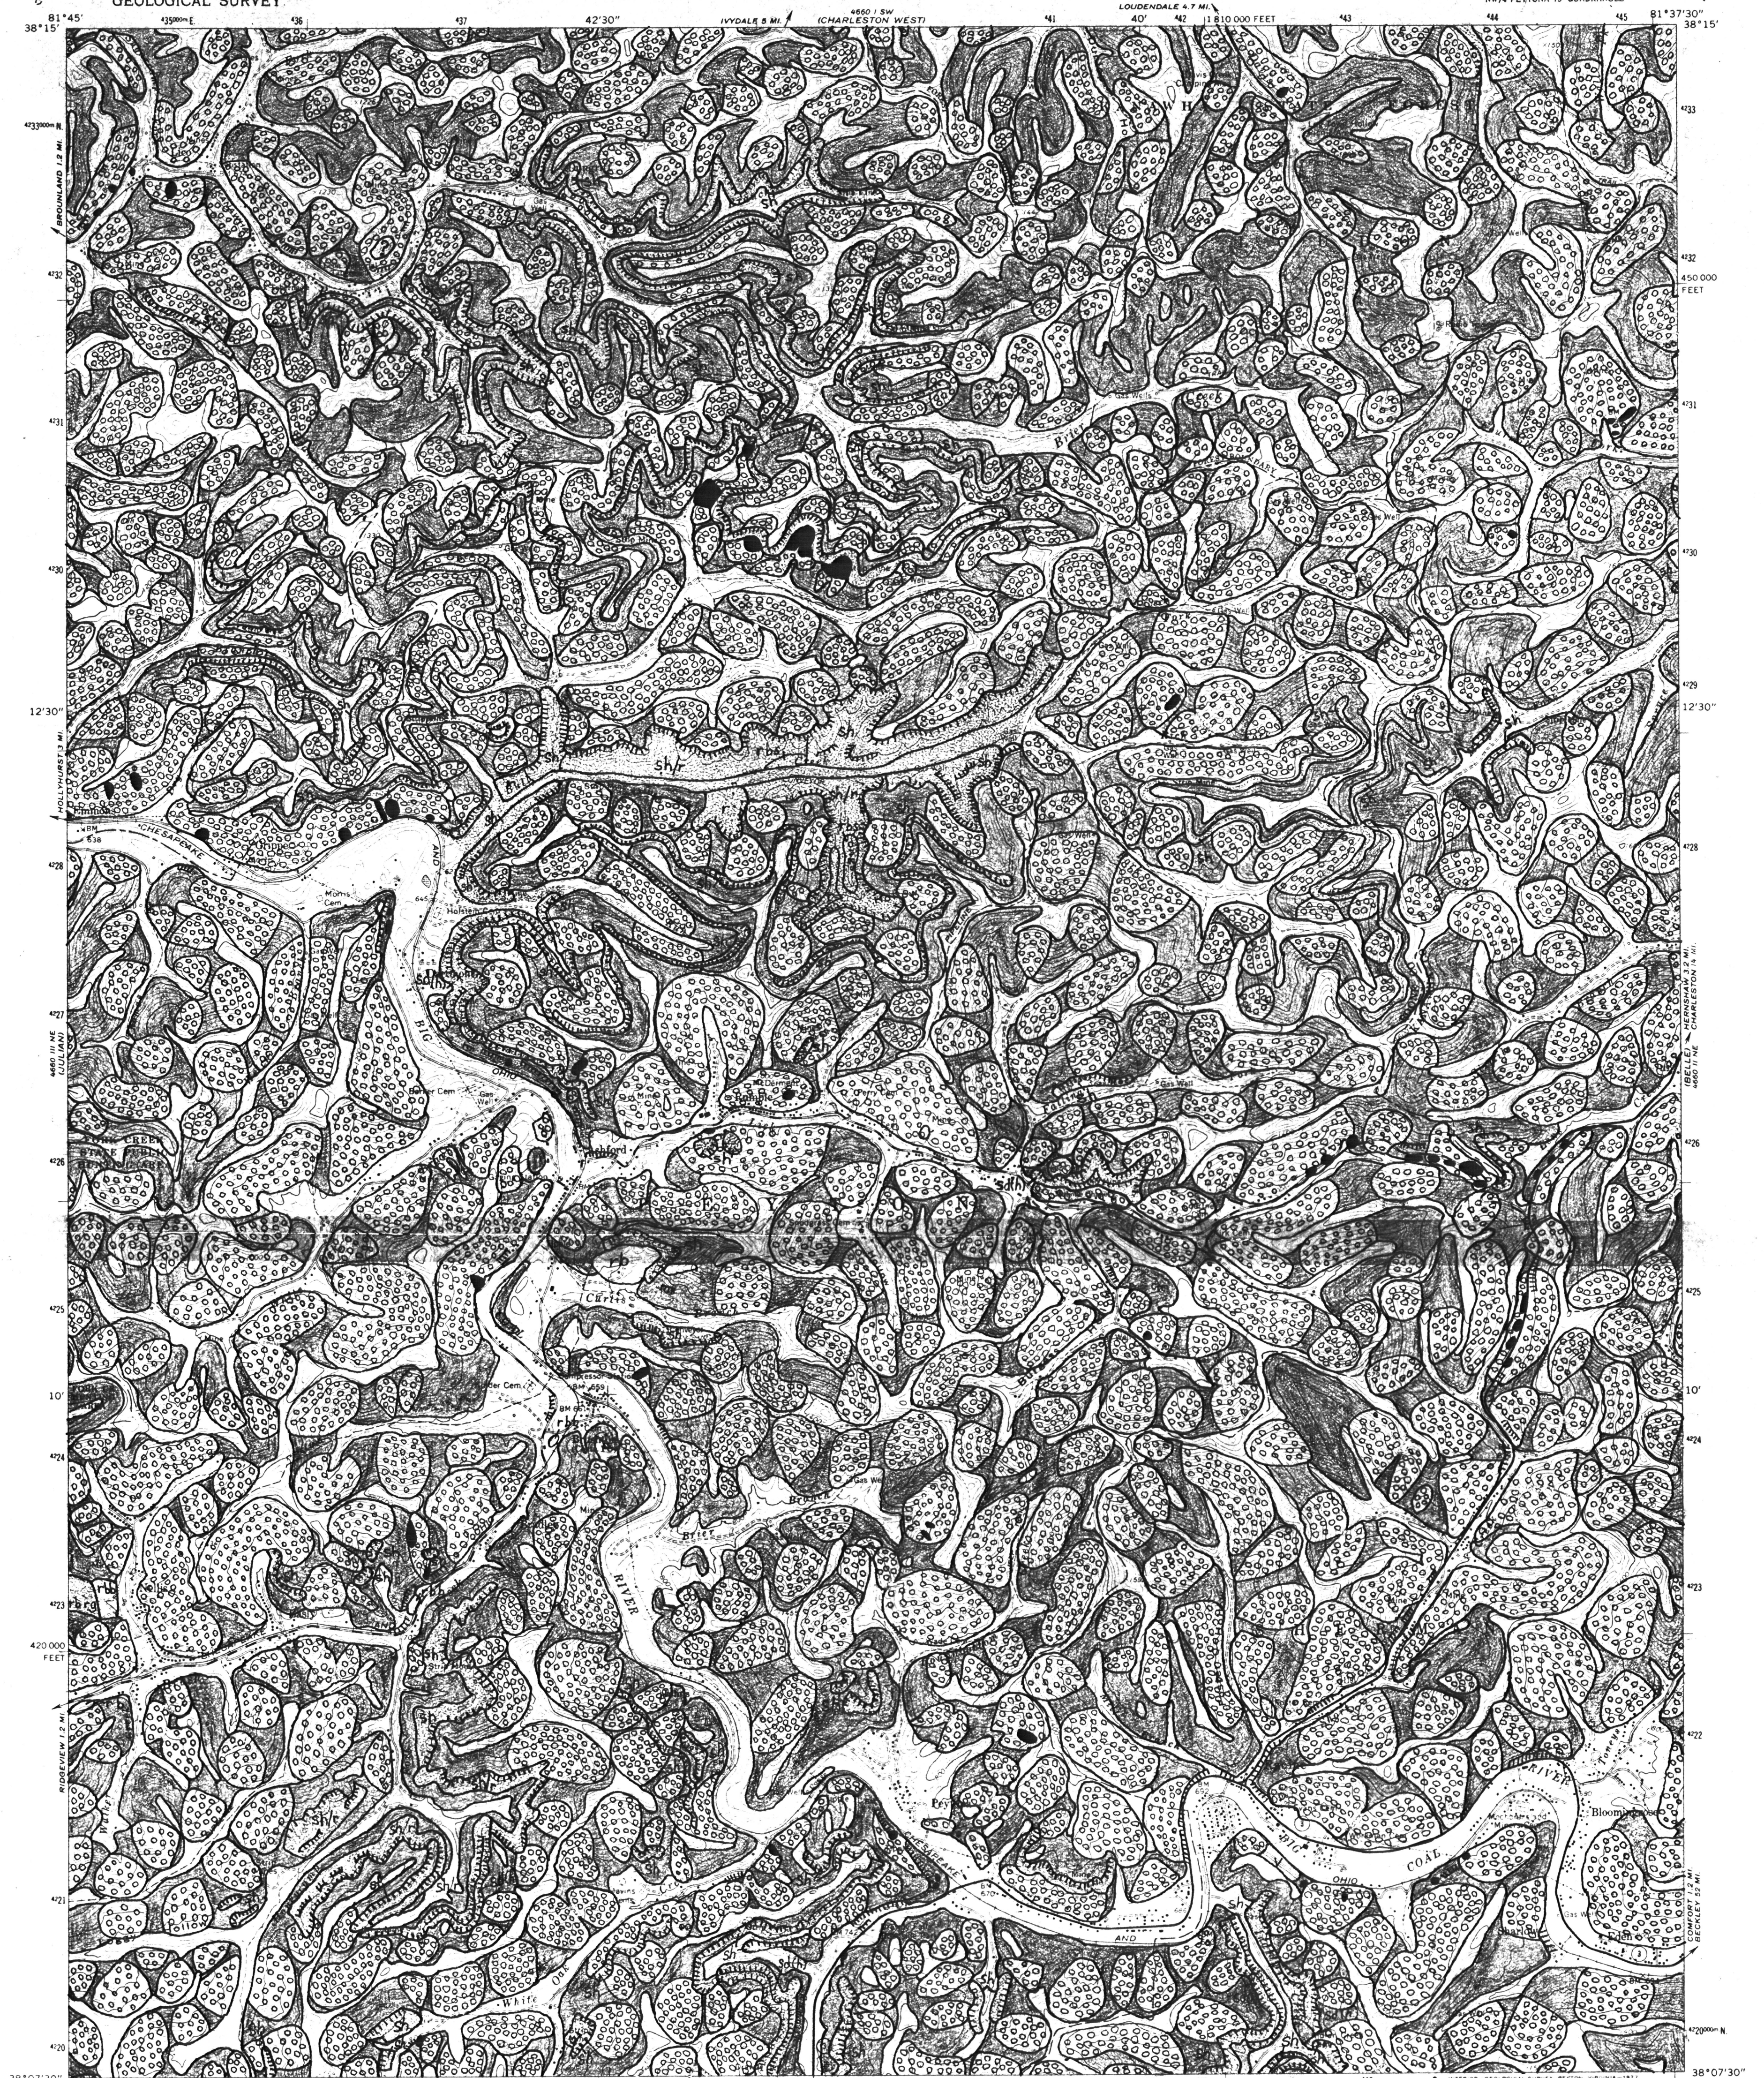
Landslides and related features interpreted  
from aerial photographs:  
1:60,000 SCALE BLACK AND WHITE 1960  
1:125,000 SCALE COLOR INFRARED 1973  
1:60,000 SCALE BLACK AND WHITE 1977

**ACTIVE OR RECENTLY ACTIVE LANDSLIDE**  
Complex landslide composed of earthflow, debris  
slide, earth and rock slump. Identified from  
historical records, and from scars, debris and  
other field evidence. Ground extremely unstable,  
sliding accelerated by excavation, loading and  
changes in drainage conditions. May include  
areas with several active slides too small to  
be shown separately.

**OLD LANDSLIDE**  
Area of extensive hummocky ground caused by  
earthflow and earth and rock slump. Lacks  
clear evidence of active sliding. Relatively  
stable in natural, undisturbed state,  
generally not affected by small structures properly  
sited in areas away from the edge of the toe,  
can be reactivated by extensive, rapid exca-  
vation, loading, and changes in ground water and  
surface water conditions. Area of old landslide  
probably includes recent ones not identified  
from field evidence or otherwise documented.  
Upslope boundary of landslide generally defined  
by modified scarp, but downslope (toe) may be  
gradational and not well defined.

**COLLUVIAL SLOPE**  
Valley wall along major streams with slope as  
steep as 40° (85%), stony, clayey silt soil up  
to 50 ft. (15 m) thick, commonly buttressed by  
a terrace or bench at the toe of the slope, very  
susceptible to sliding by cutting of toe area,  
removal of terrace or bench, and overloading,  
slide commonly activated without apparent cause.

**AREAS SUSCEPTIBLE TO DEBRIS FLOWS AND DEBRIS  
AVALANCHES**  
Primarily shallow, narrow ravines and chutes with  
accumulation of stony colluvium generally 10 ft.  
(3 m) or less in thickness, susceptible to rapid  
movement during intense rainfall. Most ravines  
and chutes designated show evidence of former  
debris flows and avalanches. Symbol-a design-  
ates historical debris flow or debris avalanche.

**AREAS SUSCEPTIBLE TO ROCKFALL**  
Steep, locally vertical, natural and man-made  
slopes and cliffs, 15 ft. (4.5 m) or more high,  
formed dominantly of sandstone, limestone, sandy  
shale, mudstone and claystone. Interbedded mud-  
stone, claystone and shale weather rapidly leaving  
sandstone and limestone rock faces unsupported.

**SOIL AND ROCK SUSCEPTIBLE TO LANDSLIDING**  
Soil and rock similar to that involved in land-  
slides elsewhere in map area, primarily areas  
underlain by claystone, mudstone and shale  
associated with other rock types. Rock weathers  
rapidly on exposure forming clayey soil highly  
susceptible to sliding. Includes coves (U-shaped,  
shallow valleys) containing thick layers of clayey  
soil that are very susceptible to sliding where  
excavation breaks continuity of slope and where  
overloaded by artificial fill.

**AREAS LEAST PRONE TO LANDSLIDES**  
Map areas in which no patterns or symbols are shown,  
primarily valley floors, ridge tops and broad  
benches; modification by excavation and fill may  
lead to local landslides.
